**CWA COMPLIANCE EVALUATION INSPECTION REPORT**  
**U.S. ENVIRONMENTAL PROTECTION AGENCY, REGION 5**

**Facility:** E&R Livestock  
Ex. 6 (Personal Privacy)  
[REDACTED]

**Date of Inspection:** 9/18/2013

**Report Date:** 7/1/2014

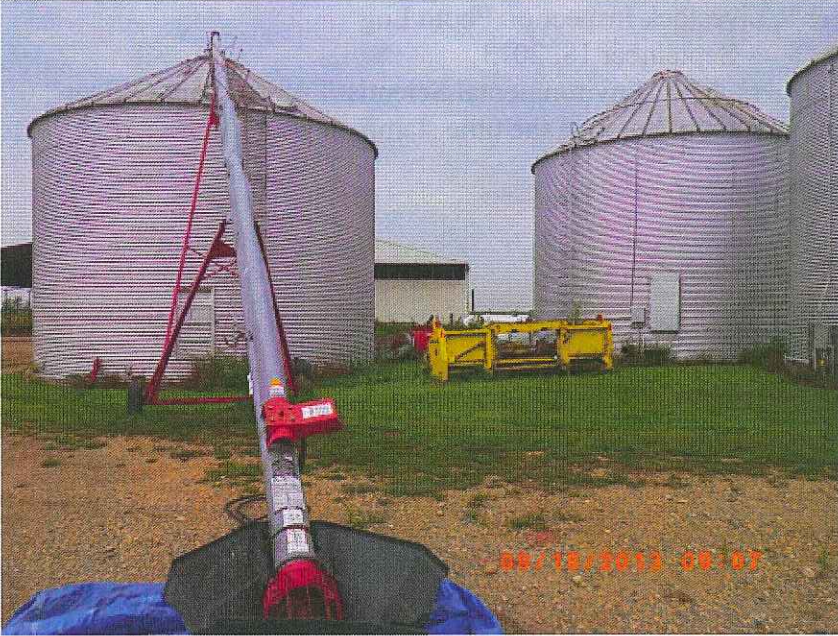
IMGP0276: Grain silos.  
 Location: West of machine shed.  
 Facing: West  
 Date/Time: 09/18/13 10:07 A.M.

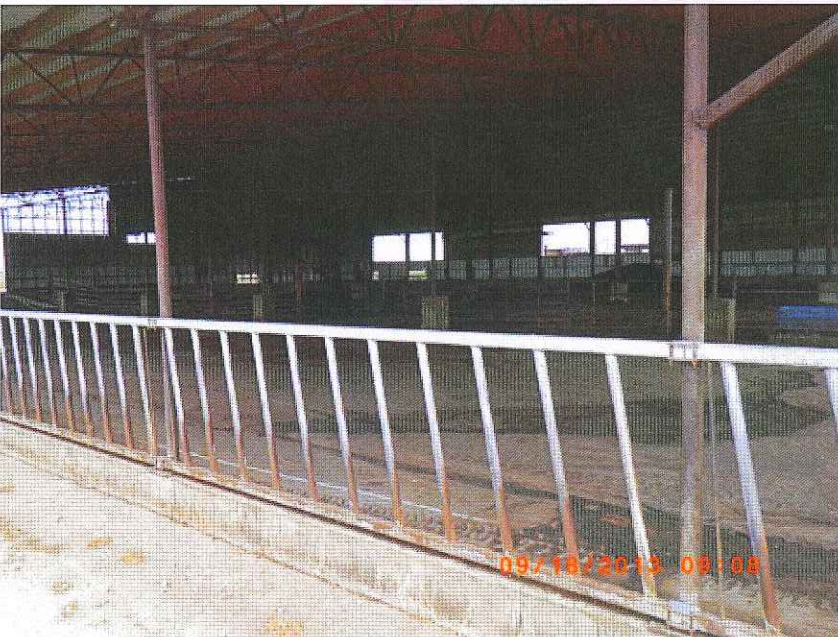
IMGP0277: Pen 1 is empty on the day of the inspection.  
 Location: South of Pen 1 barn.  
 Facing: Northwest  
 Date/Time: 09/18/13 10:08 A.M.

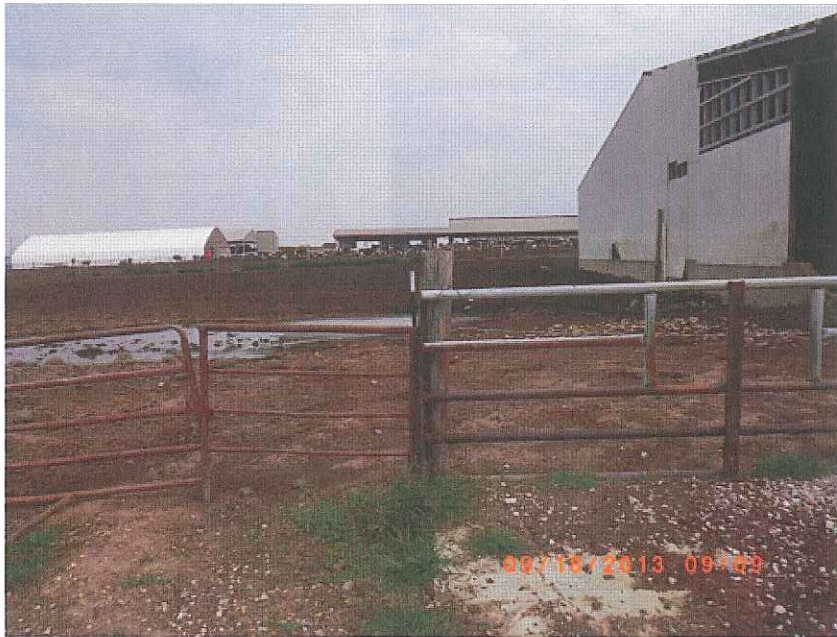
IMGP0278: Pen 1 fencing.  
 Location: South of Pen 1.  
 Facing: North  
 Date/Time: 09/18/13 10:09 A.M.

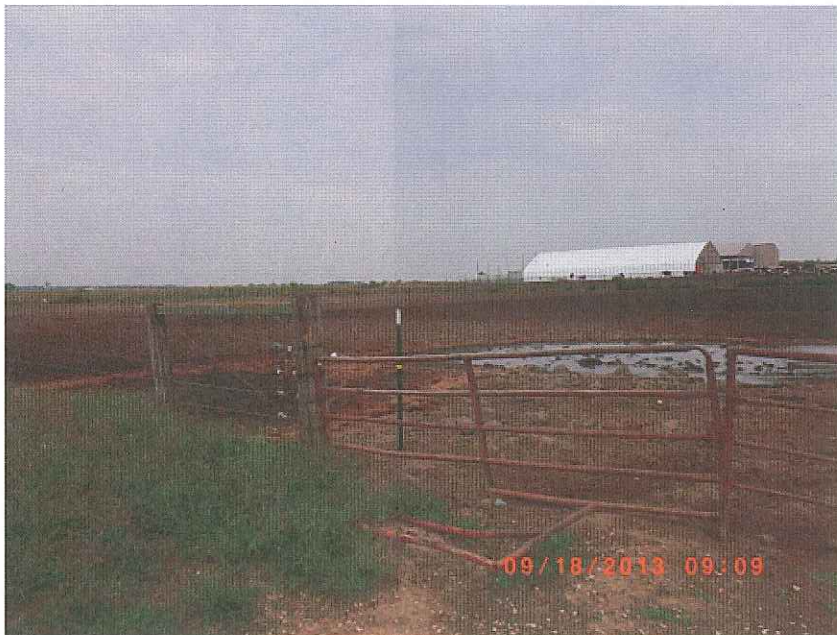
IMGP0279: Runoff from Pen 1 would flow to a vegetated field to the south.  
 Location: South of Pen 1.  
 Facing: Northwest  
 Date/Time: 09/18/13 10:09 A.M.

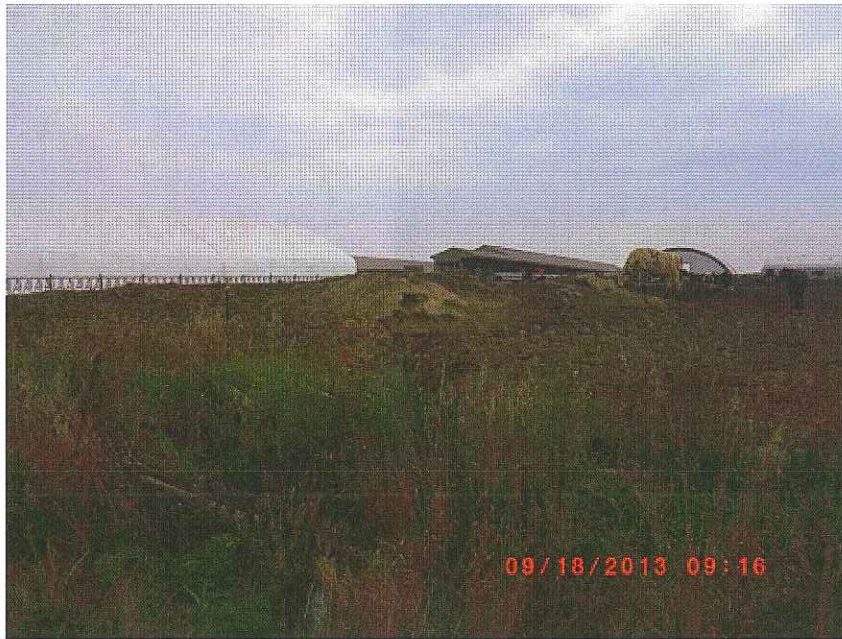
IMGP0284: Clay berm in Pen 10 for cattle to use.

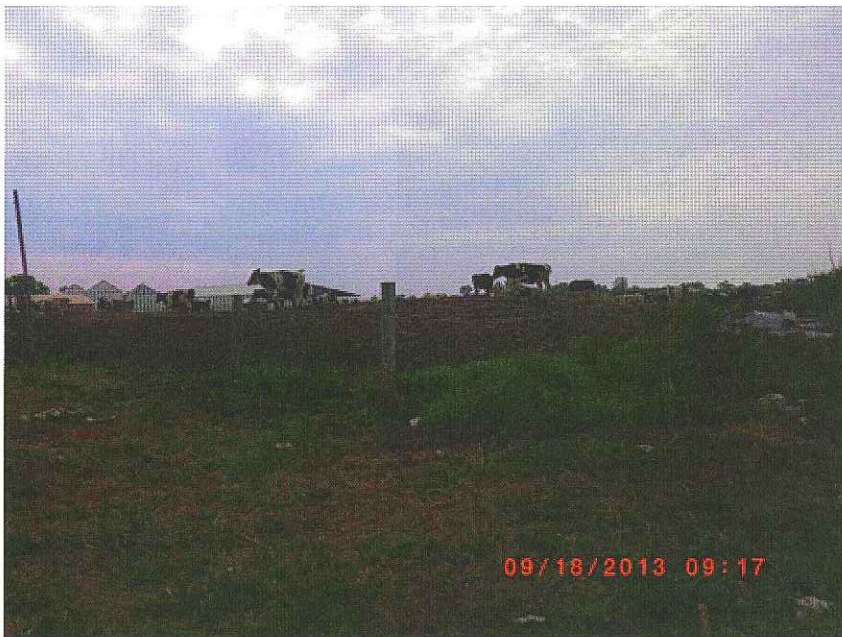
IMGP0285: Cattle in Pen 10. No evidence of runoff of manure and process wastewater from Pen 10 on the day of the inspection.

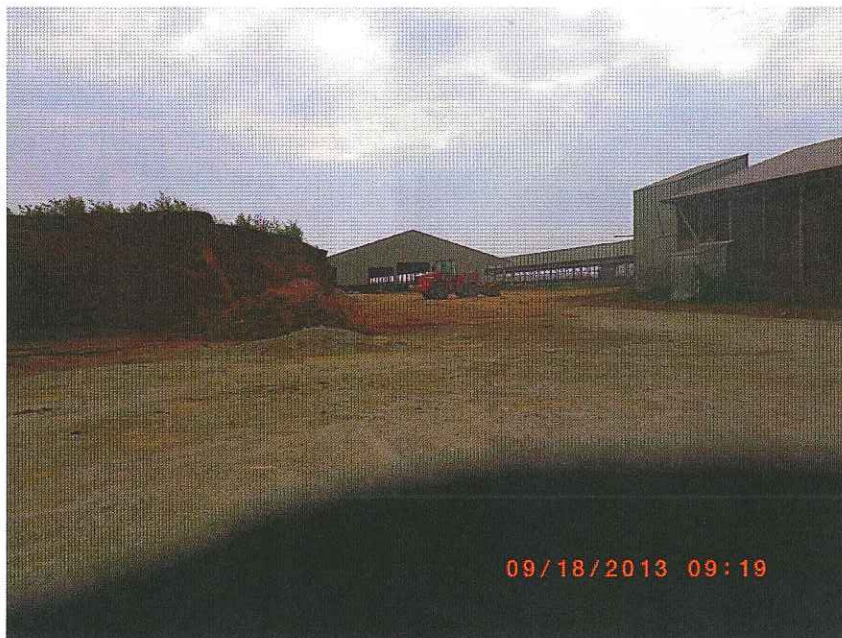
IMGP0288: Silage stacked on silage pad. Silage is not covered or in bunkers

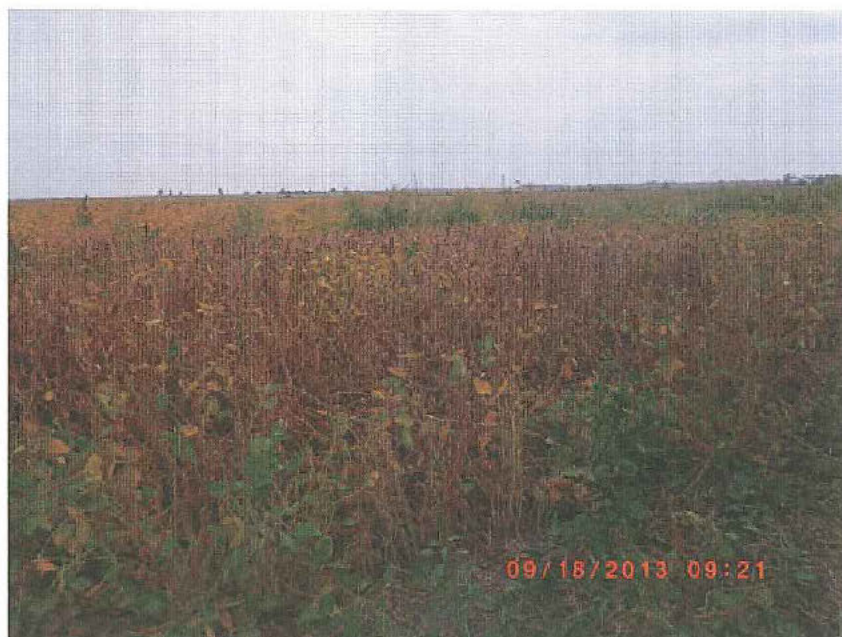
IMGP0291: Soybean field north of silage pile appears to be nutrient burned.

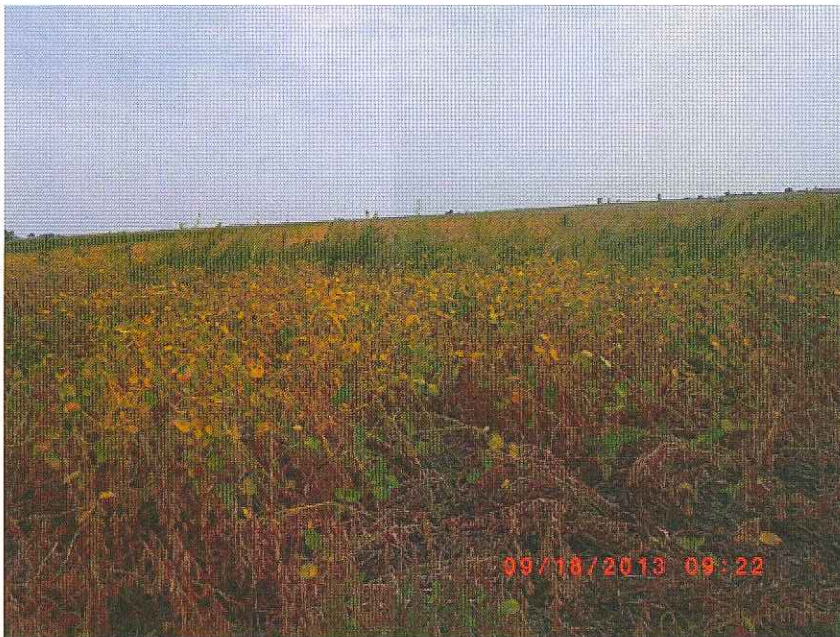
IMGP0293: Soybean field north of silage pile appears to be nutrient burned.  
 Location: North of silage pile.  
 Facing: Northeast  
 Date/Time: 09/18/13 10:22 A.M.

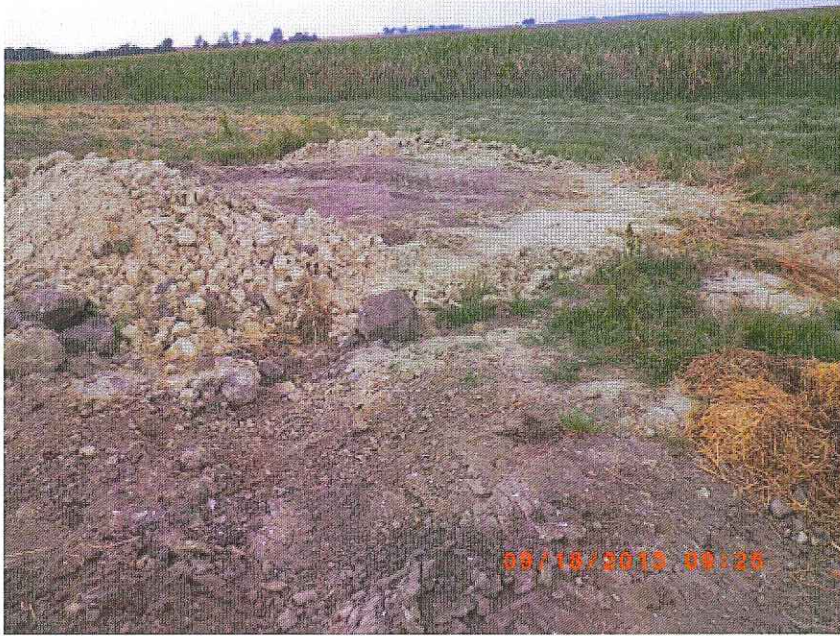
IMGP0296: EPA did not observe any improper mortality management on the day of the inspection.

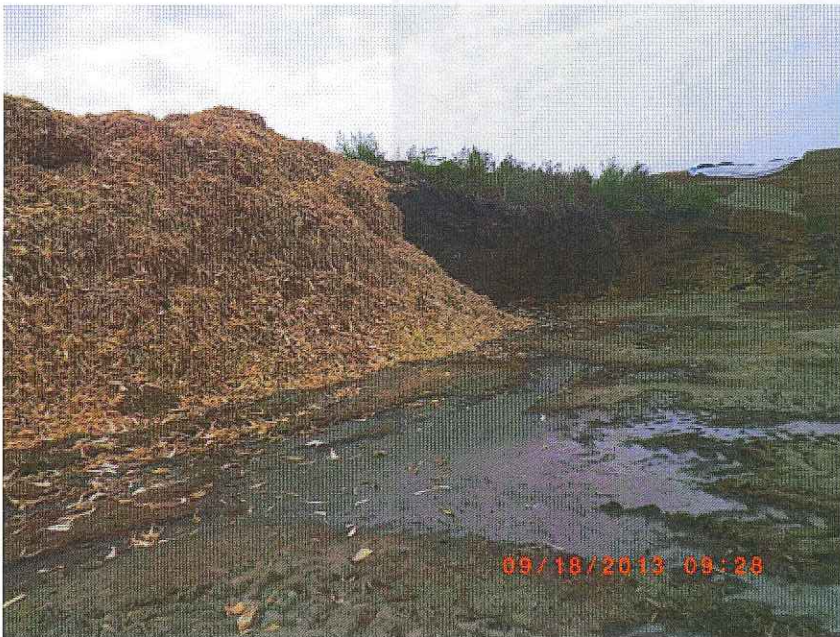
IMGP0297: Leachate from the silage pile flows to the north to a crop field. Corn shucks are also stacked in a pile in this area.

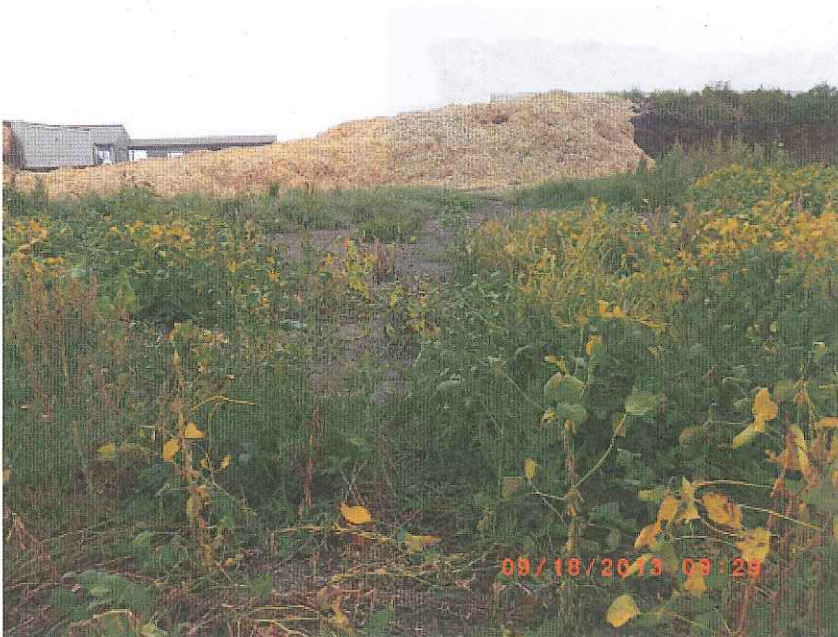
IMGP0299: EPA followed leachate pathway into the crop field as far as evidence of the leachate was visible.

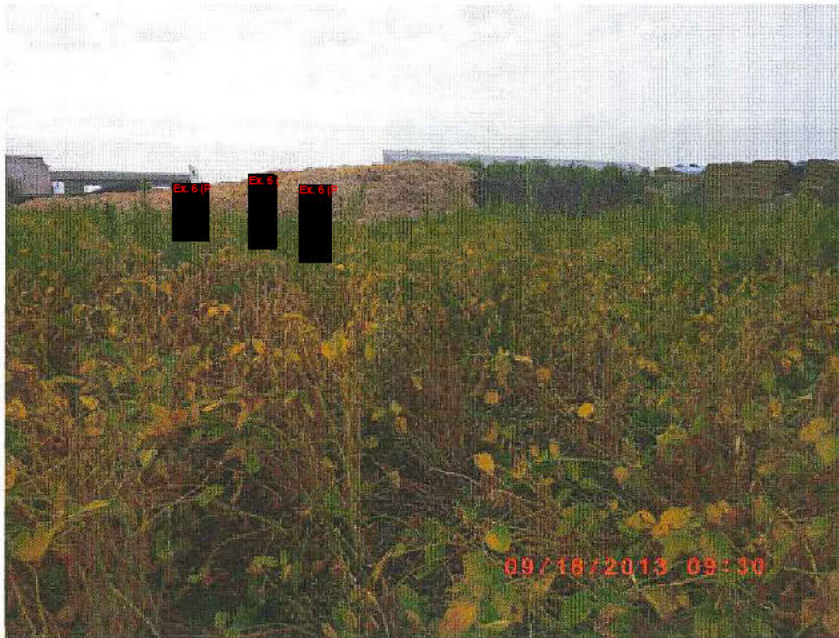
IMGP0300: Leachate pathway eventually was not visible in the crop field.

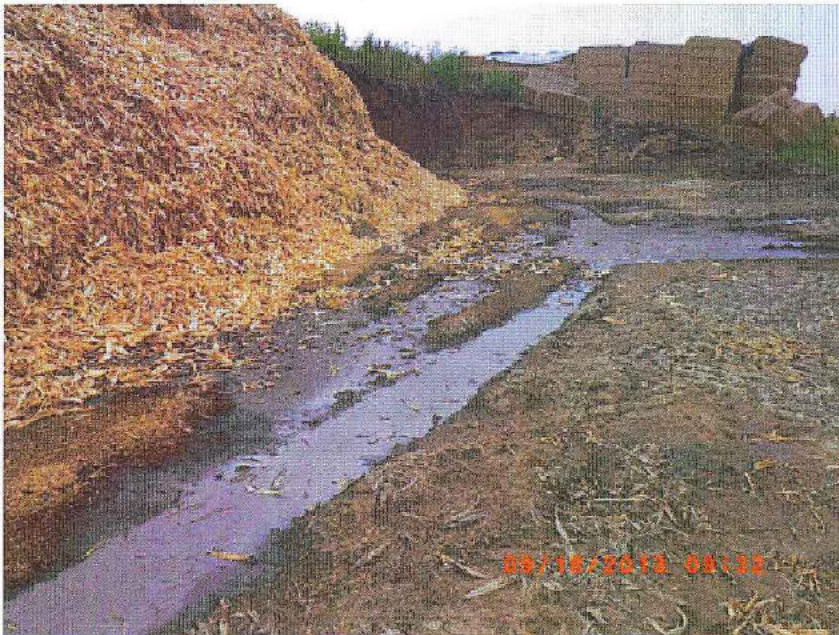
IMGP0301: Leachate pathway from silage pile.

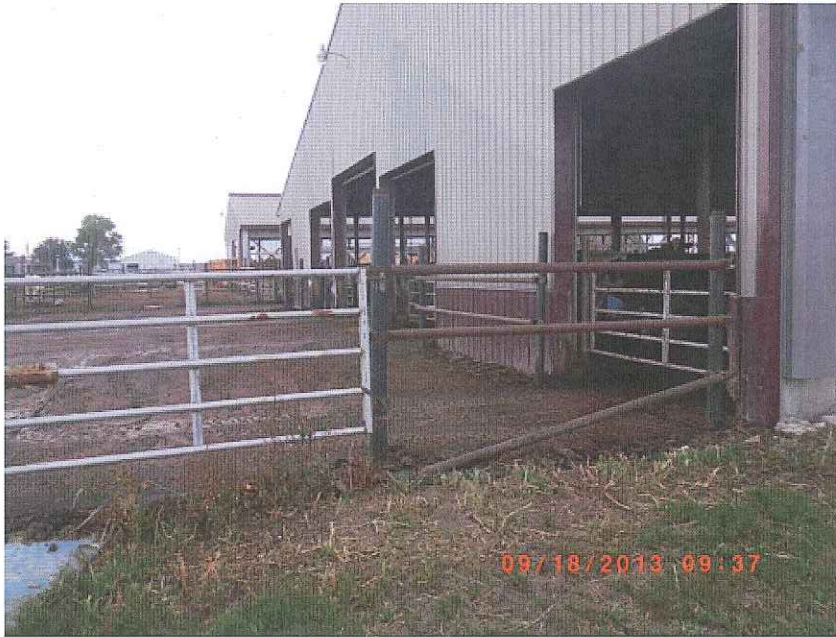
IMGP0306: Open pen attached to the east side of Pen7. Manure from this barn is manually scraped directly to Pond #1, just to the east of the open pen.

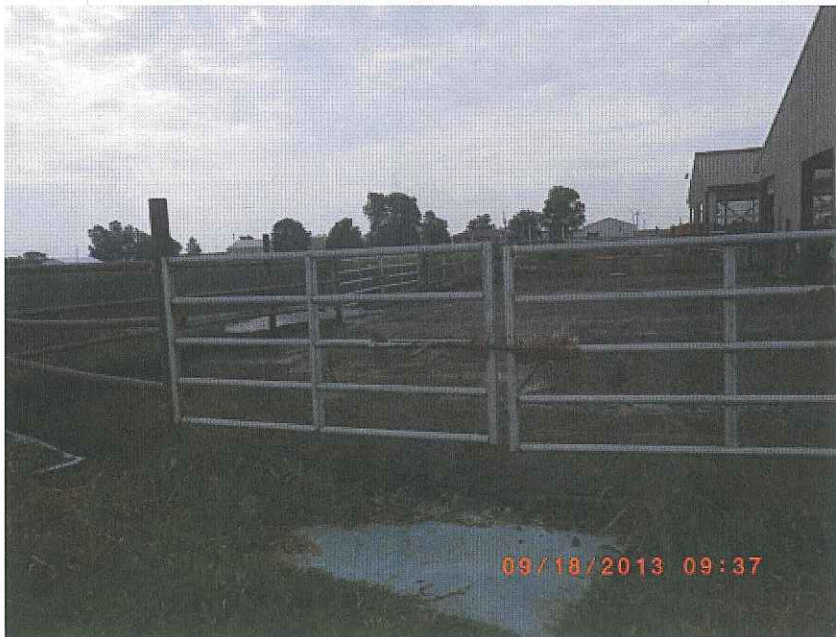
IMGP0307: Although there was some manure outside the pen, EPA did not observe any runoff pathways from the open pen to a water of the U.S.

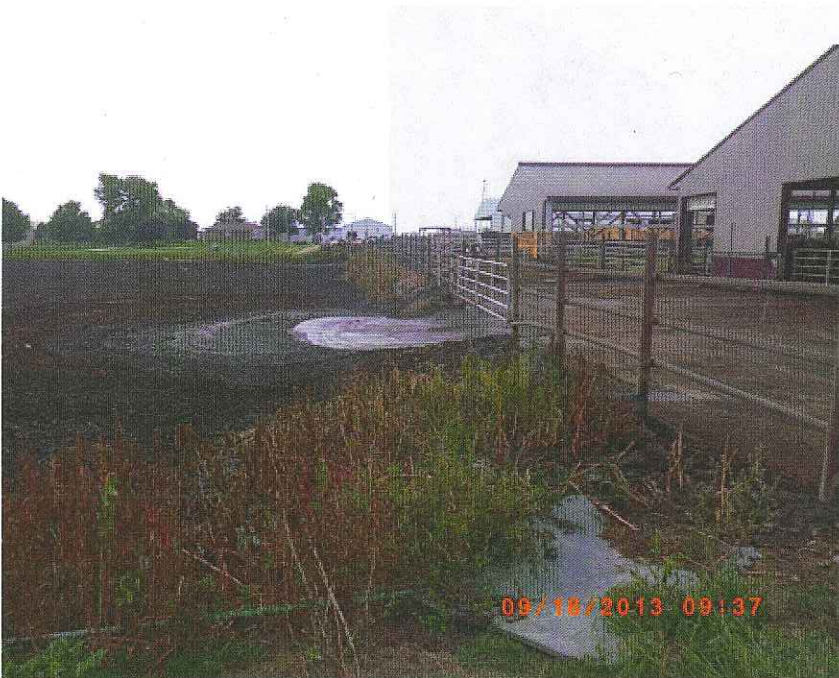
IMGP0308: Manure is pushed into Pond #1. Manure level in Pond #1 was high.

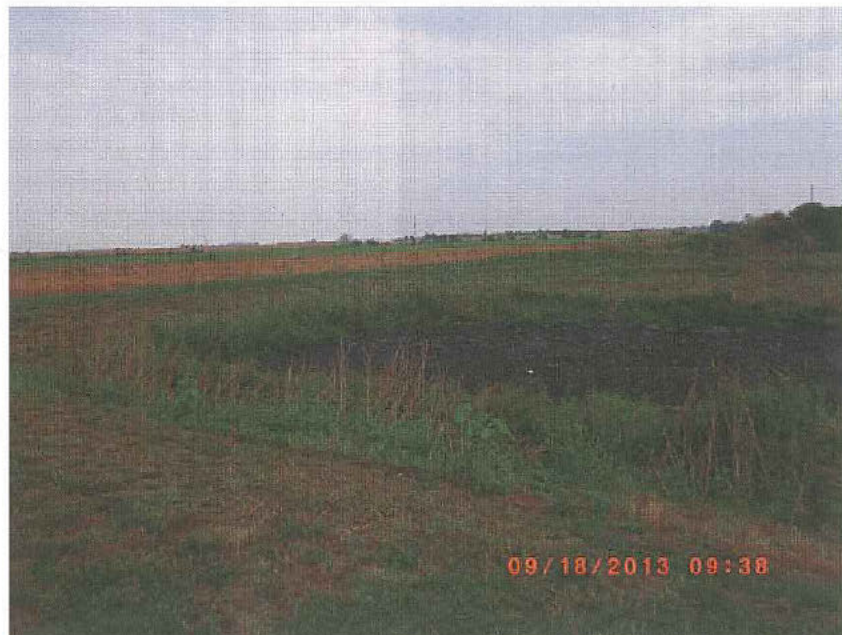
IMGP0311: Pond #2 is narrower than Pond #1. It receives the overflow from Pond #1 via a weir.

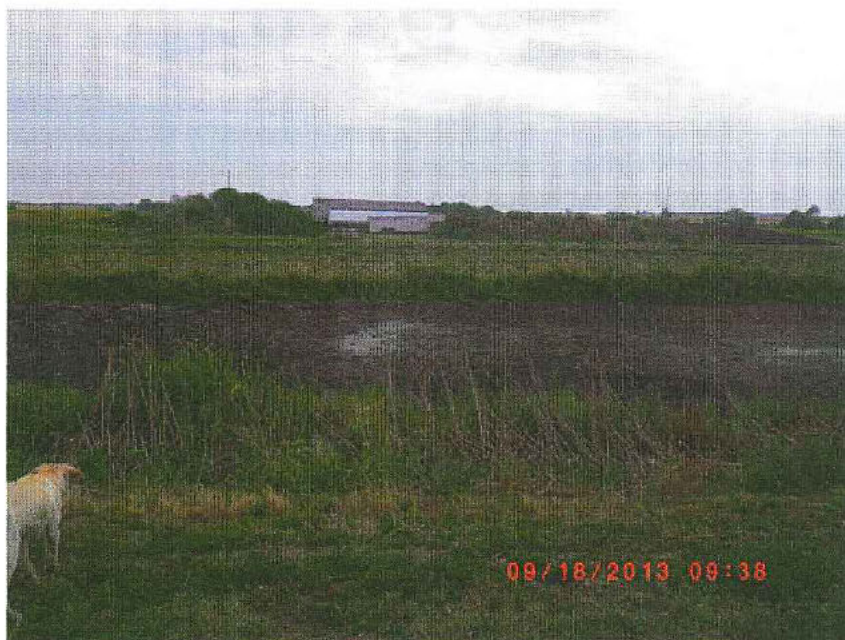
IMGP0312: Pond #2 appears to have approximately 4' of freeboard.

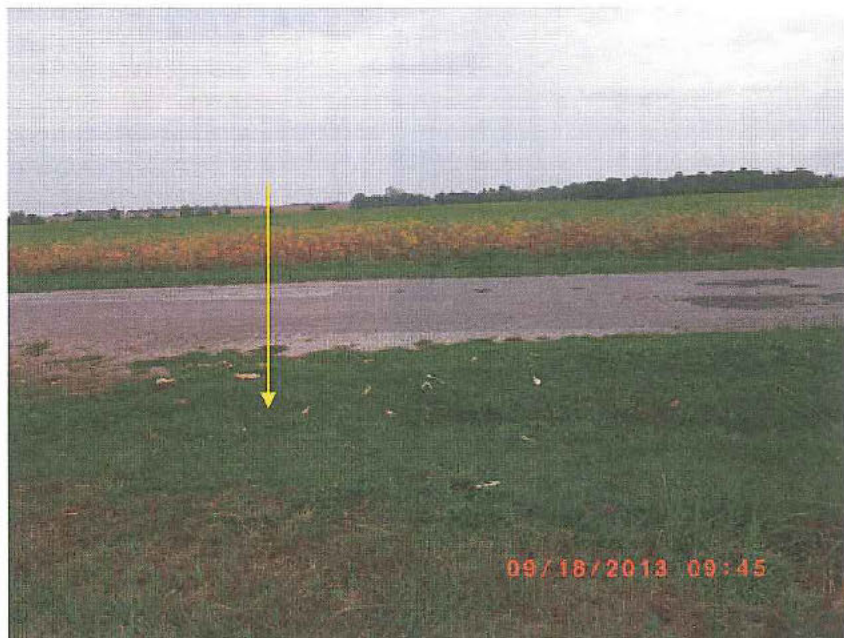
IMGP0320: The area to the east of the ponds is on a topographic high. Arrow indicates location of the beginning of the roadside ditch that flows to the south (to the right in this photo) along County Road 2600 E.

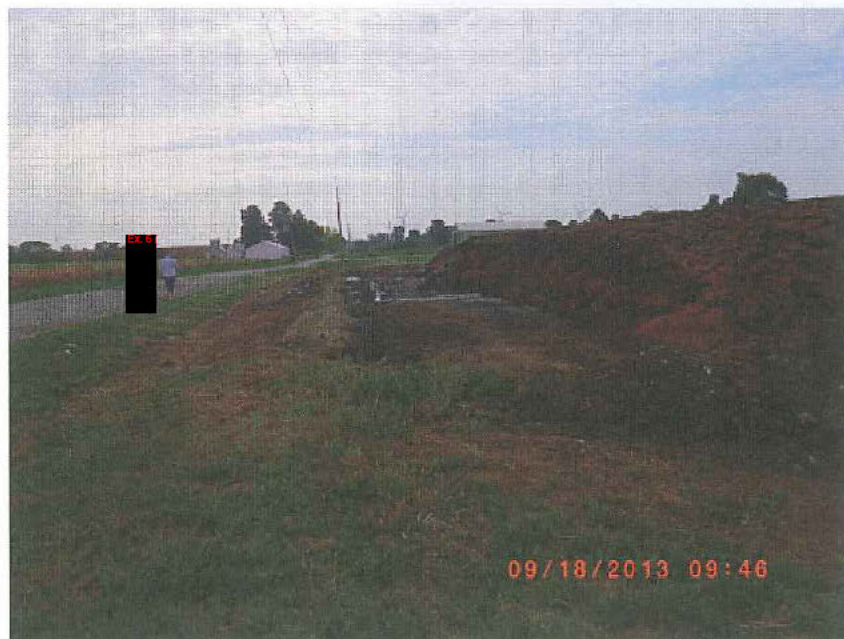
IMGP0321: Corn gluten meal pile is not covered.

The manner in which the Corn Gluten is being stored is an apparent violation of Sections 12(a) & (d) of the Illinois Environmental Protection Act.

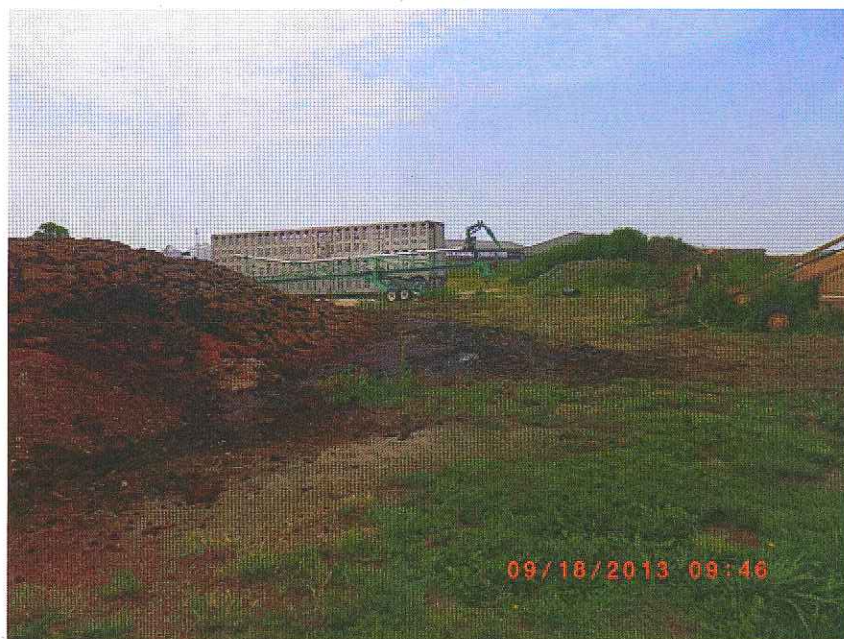
IMGP0323: Leachate from corn gluten meal pile flows to off the pile.  
 Location: Northeast of corn gluten meal pile  
 Facing: West  
 Date/Time: 09/18/13 10:46 A.M.

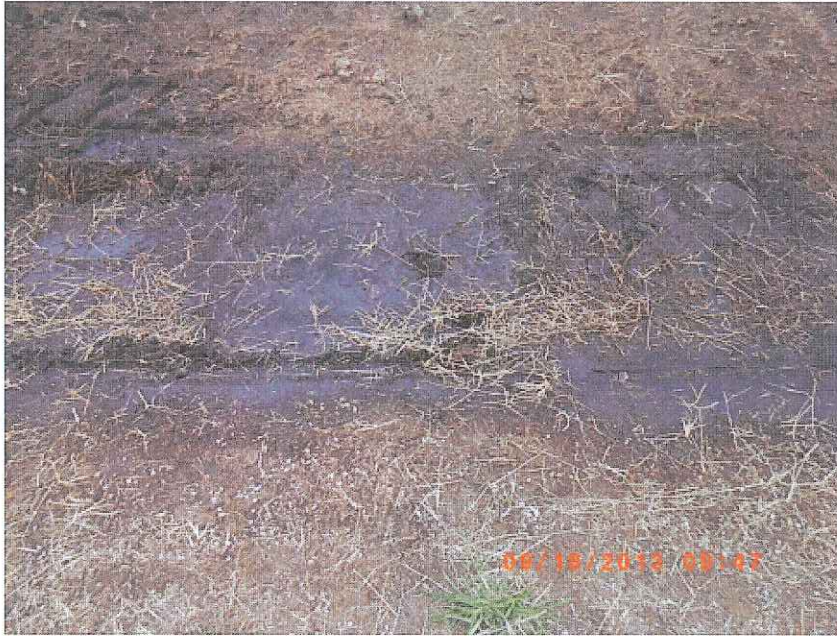
IMGP0324: Leachate from corn gluten meal is in roadside ditch. Ditch had recently been scraped, but evidence of the leachate was still in the ditch.  
 Location: Roadside ditch east of corn gluten meal pile  
 Facing: Down  
 Date/Time: 09/18/13 10:47 A.M.

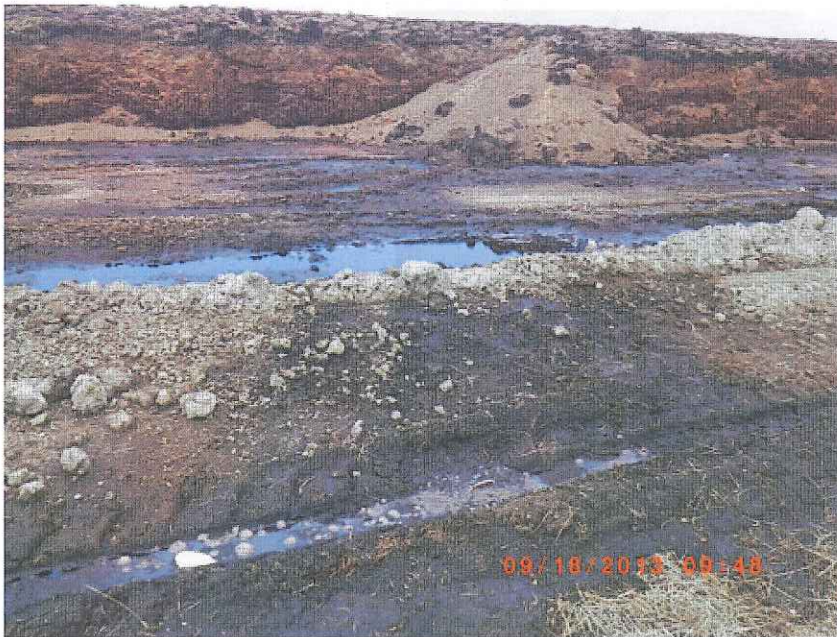
IMGP0325: Lime berm has been created to prevent leachate from corn gluten meal from reaching the roadside ditch, but the leachate appears to be flowing through and under the berm and reaching the ditch.  
 Location: Roadside ditch east of corn gluten meal pile  
 Facing: West  
 Date/Time: 09/18/13 10:48 A.M.

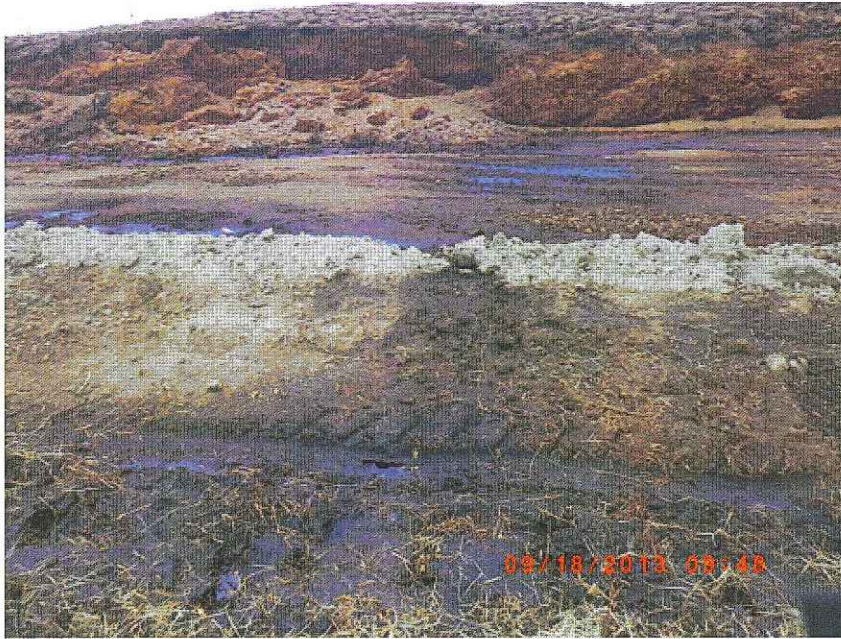
IMGP0326: Berm to prevent corn gluten meal leachate from reaching the roadside ditch has been compromised and leachate continues to flow to the ditch.

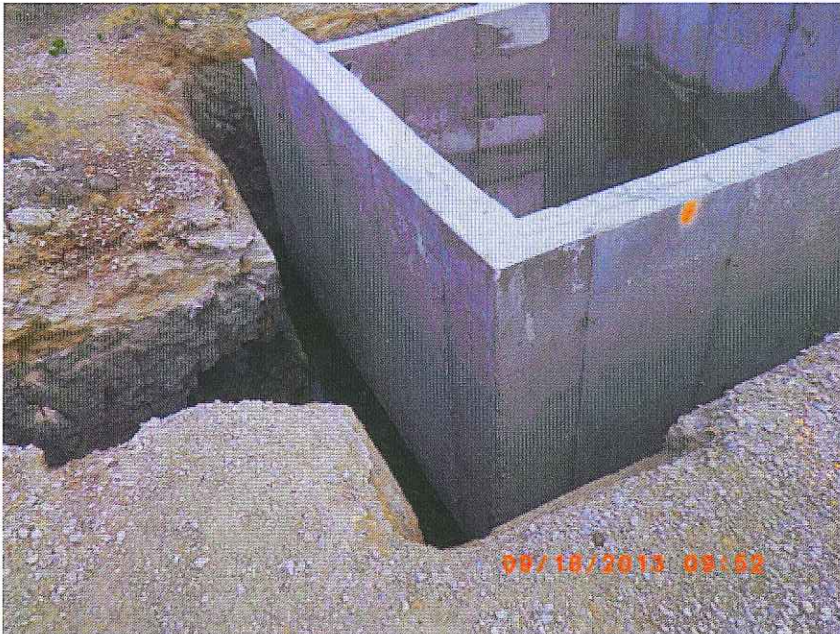
IMGP0335: Concrete pit installed in the ground will accept the stormwater and process wastewater from the corn gluten meal pad.

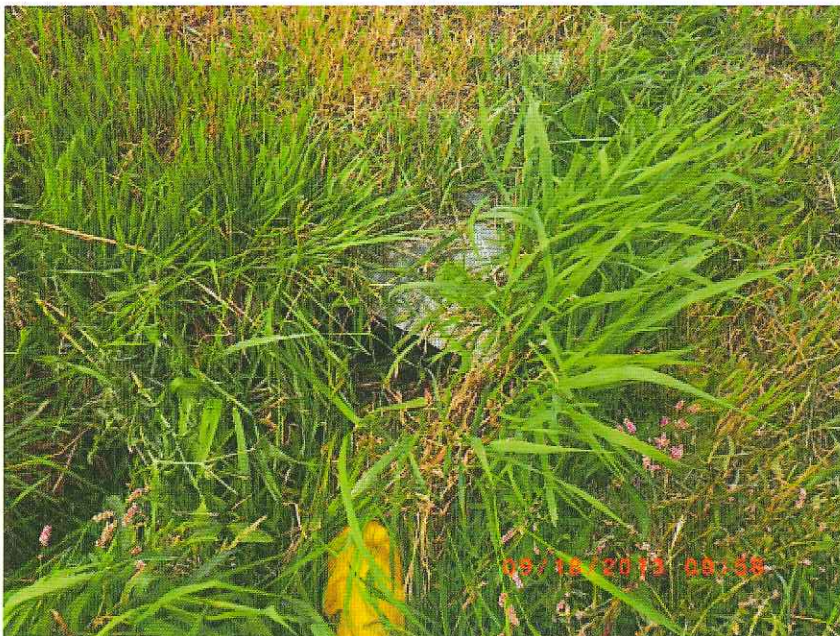
IMGP0339: Outlet pipe for storm water from roof water for the North and South Barns.

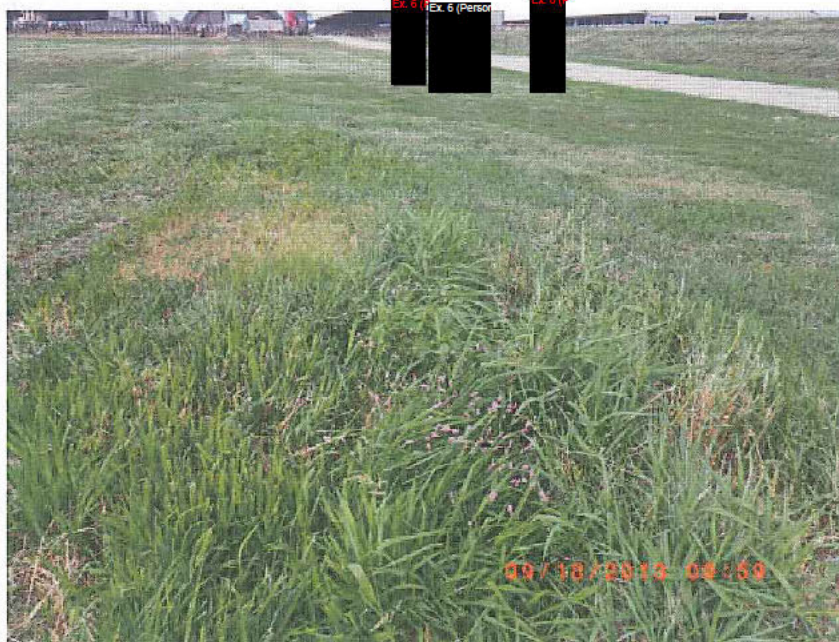
IMGP0340: Location of outlet for storm water pipe that originates in the yard between the pens 4 and 7.

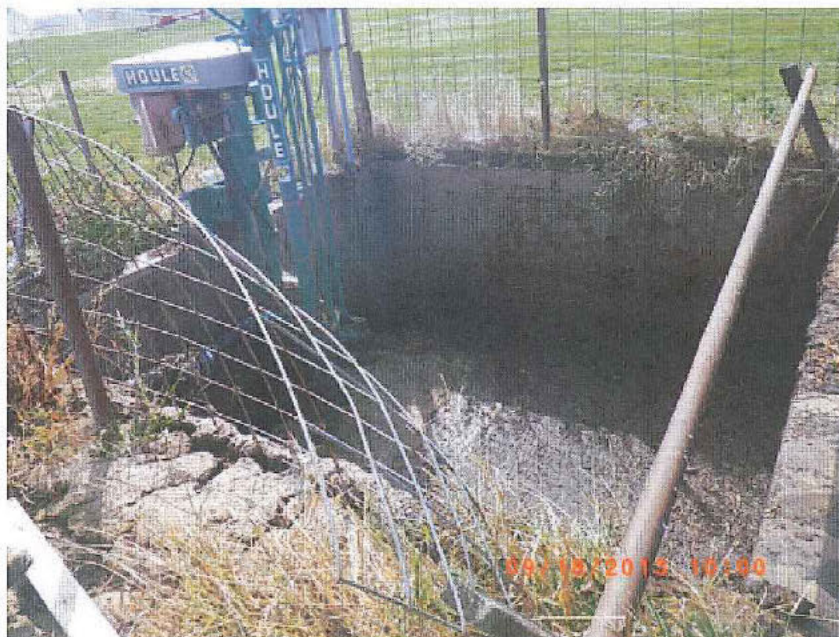
IMGP0341: Manure pit that receives manure and process wastewater from Pen 3. Manure and process wastewater is then pumped to Pond #1.

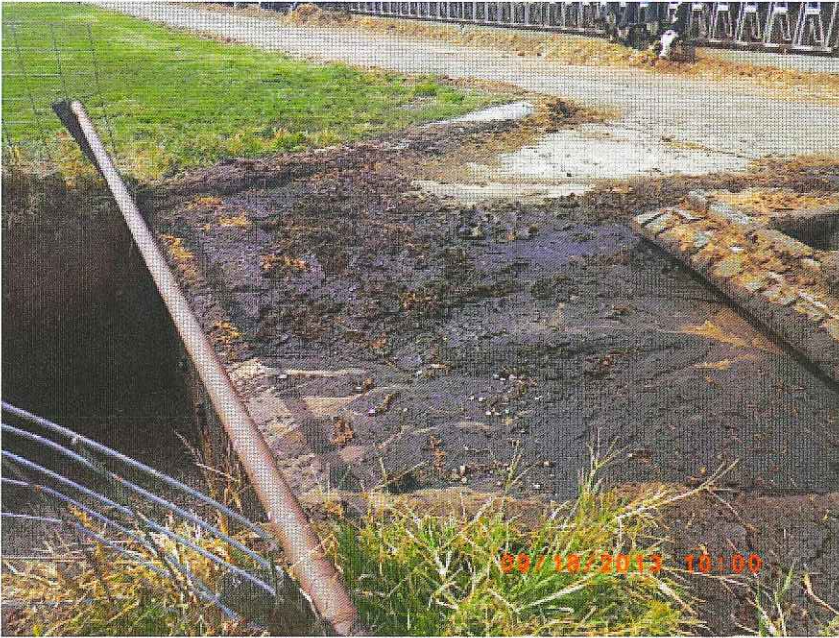
IMGP0342: Manure is scraped and also flows via gravity to the pit. Dirt curbing directs the flow of process wastewater from Pen 3 to the pit.

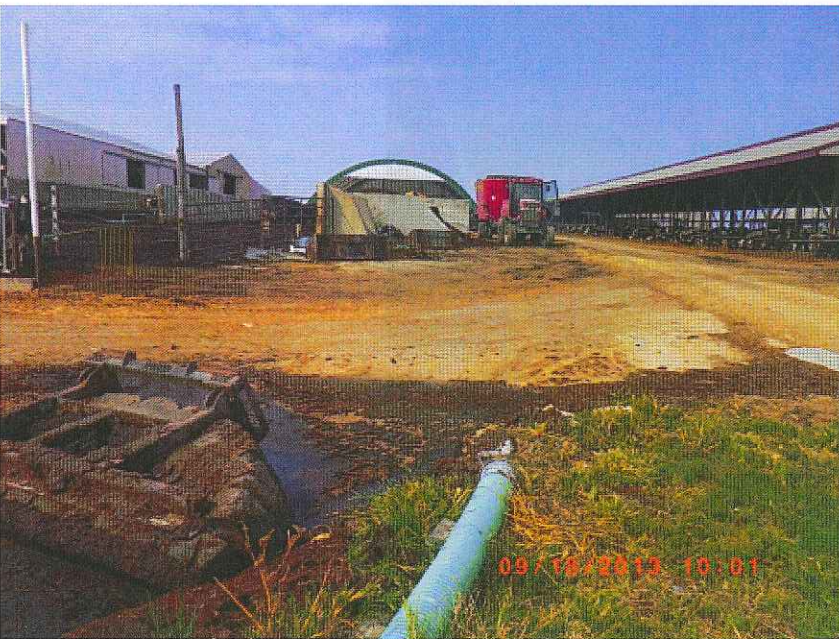
IMGP0343: Process wastewater flows via gravity to the manure pit for Pen 3. Note the berm to direct the flow of water alongside the driveway.

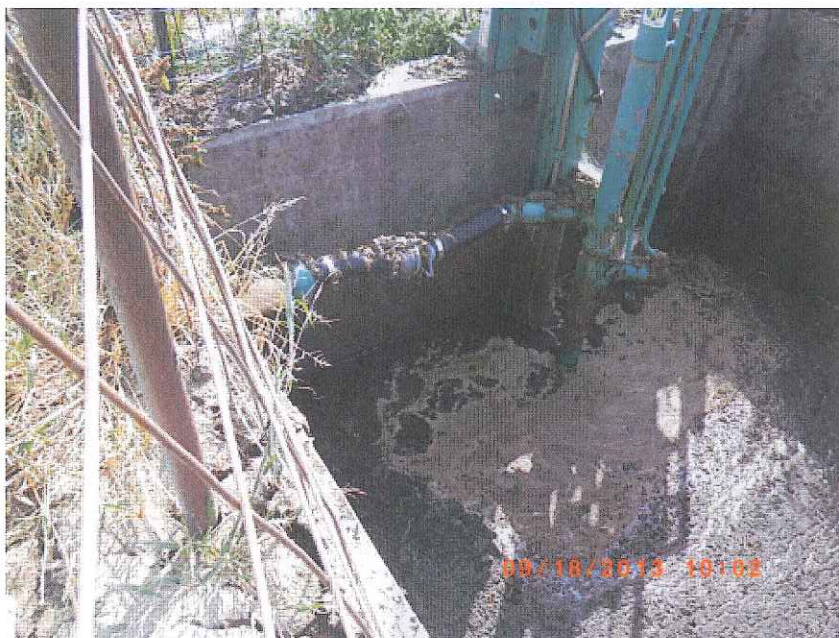
IMGP0344: Pipe in pit pumps manure to Pond #1.

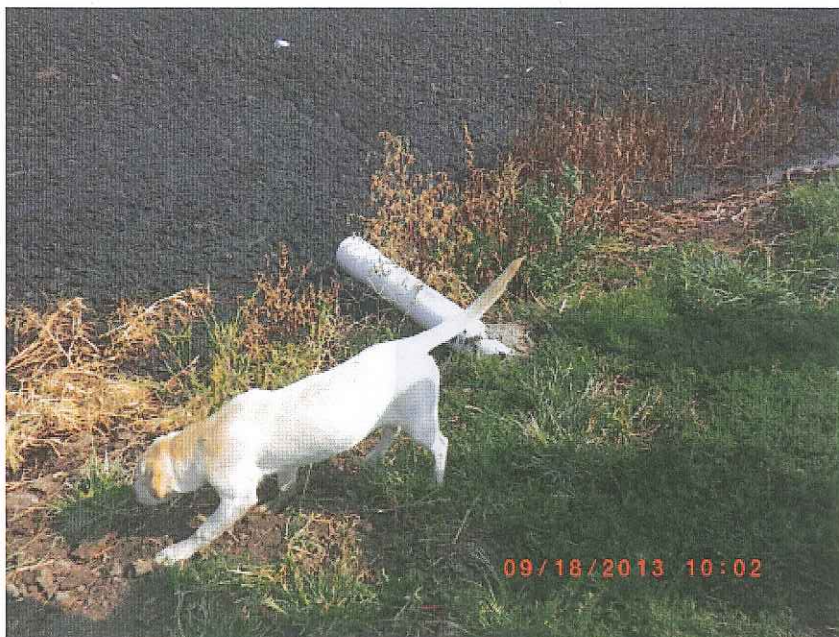
IMGP0345: Lucy walks near the outlet of pipe from manure pit to Pond #1.

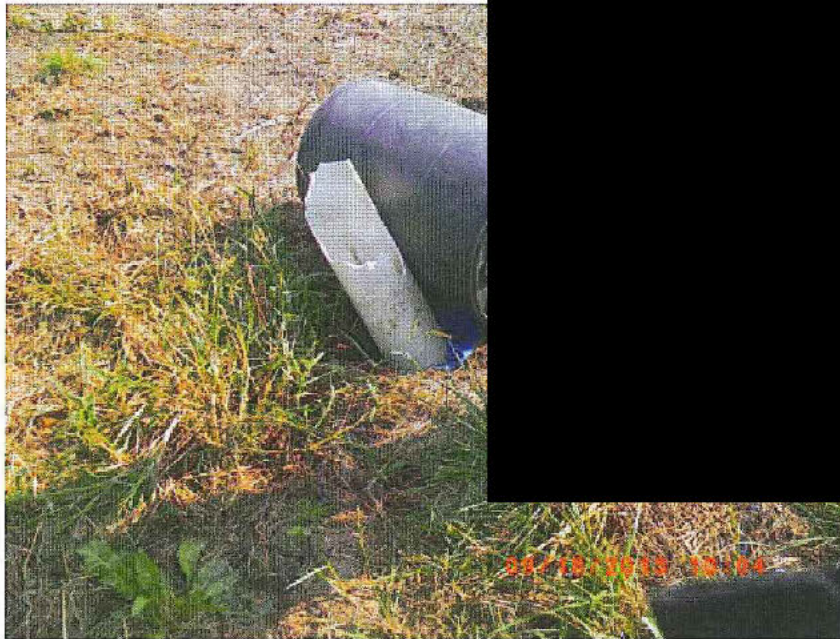
IMGP0346: The inlet pipe in the yard between pens 4 and 7 receives all roof water from the two barns.

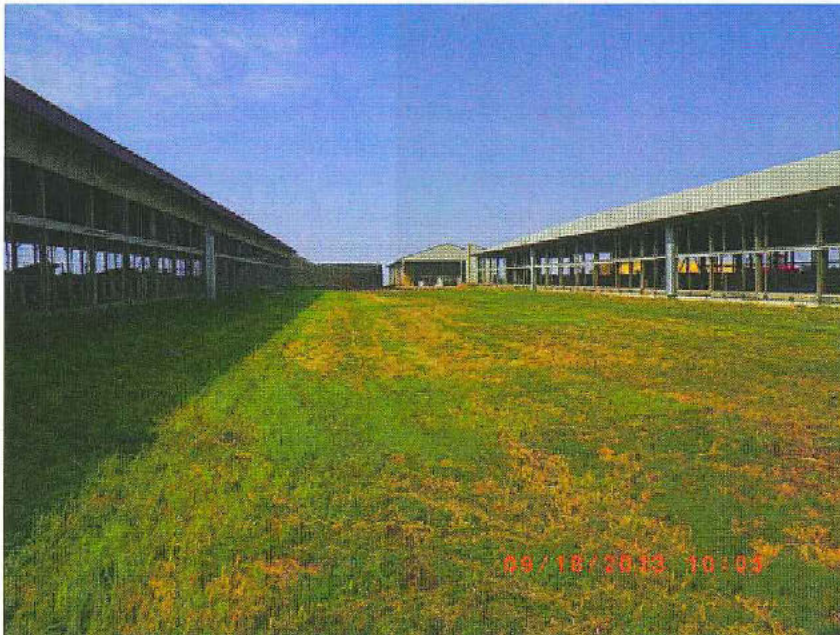
IMGP0347: The vegetation in the yard between pens 4 and 7 is mowed and there is no evidence of pollutant pathways to the inlet pipe.

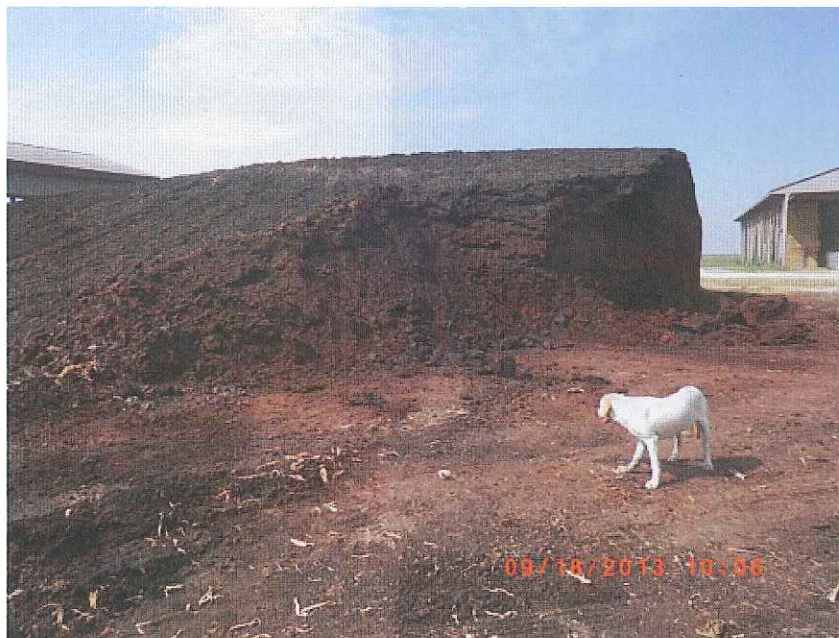
I walked west and inspected the grassed area between pen 4 and pen 7. I noted the inlet pipe which receives the roof water (Attachment 2: IMGP0346, IMGP0347). An additional pile of corn gluten meal is located west of pen 4. The ground around the pile

IMGP0348: Another corn gluten meal pile is located west of the yard between pens 4 and 7.

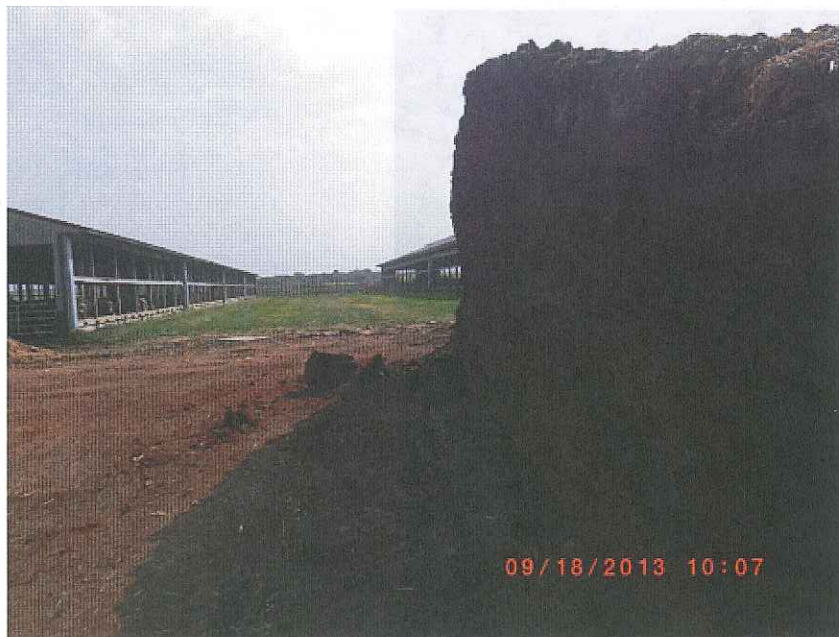
was sloped to the east. Runoff from this area could flow to the inlet pipe between pens 4 and 7 which could result in a discharge through the pipe and eventually to the roadside ditch. No flow path was observed on the day of the inspection (Attachment 2: IMGP0348, IMGP0349).

IMGP0349: The yard between pens 4 and 7 is sloped to the east. Any process wastewater from the corn gluten meal pile to the west of the yard would flow to the east. EPA did not observe any runoff pathways from the corn gluten meal to the inlet pipe.

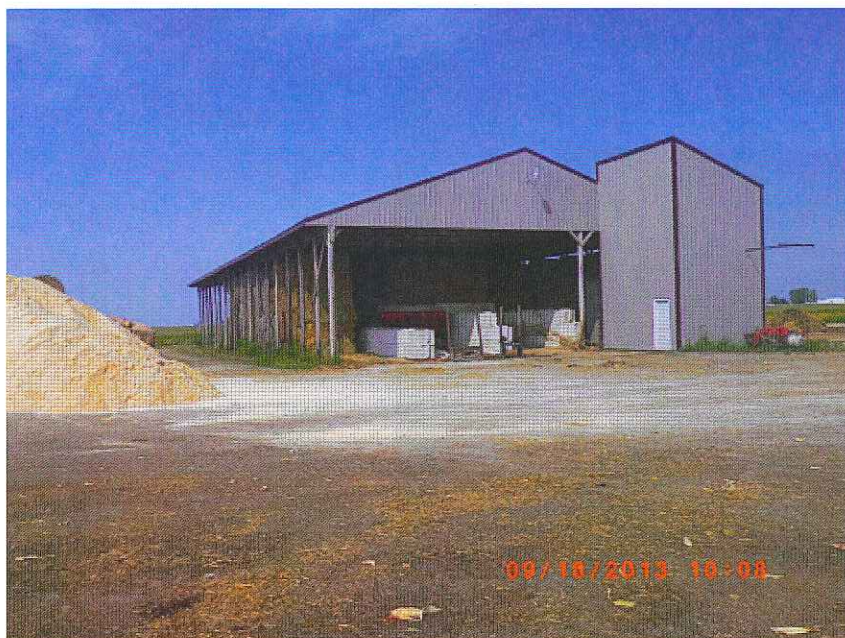
IMGP0350: Sawdust in pile outside the barn and straw is baled and stacked in the barn.

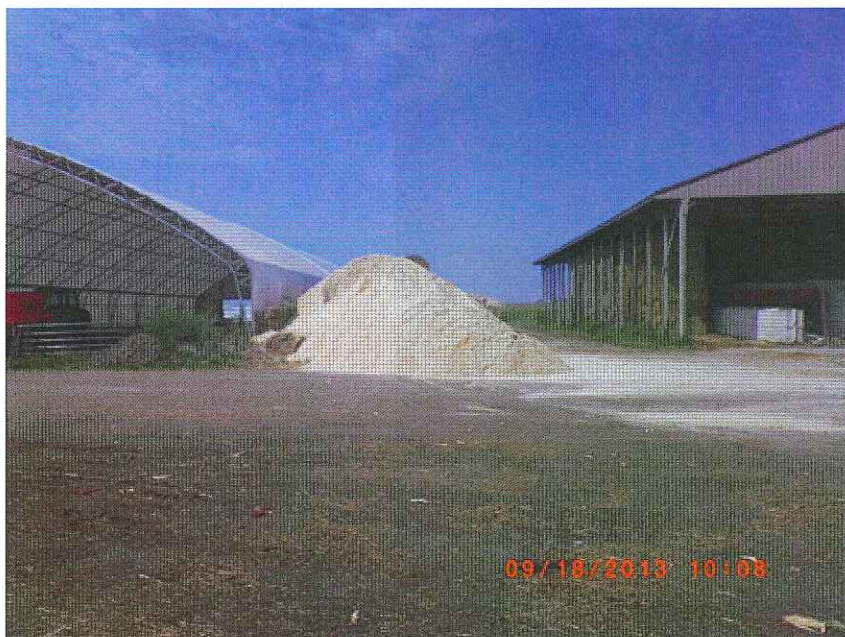
IMGP0351: Sawdust pile.

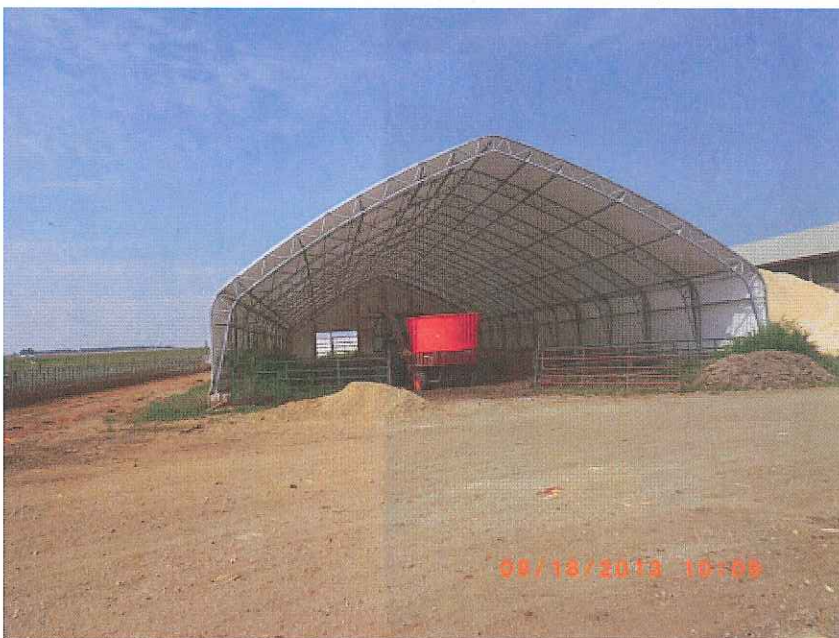
IMGP0352: Fabric building.  
 Location: Northwest of pens 4 and 7.  
 Facing: West  
 Date/Time: 09/18/13 11:09 A.M.
